Traffic Incident 17SIT0132571

Bridge information System Structure Summary

Structure Condition Inspection Report

Structure Id 832 Name _____
 Inspection Date 16-MAY-2018 Inspection Level 2 Level 3 Underwater

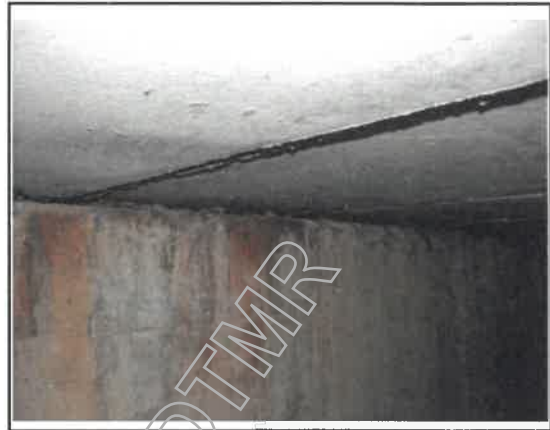
Id **Date**
Film / Exposure Number **Sketch No**
Description
 Exception.
Mod **Category** **Number** **Comp Code** **Comp No**

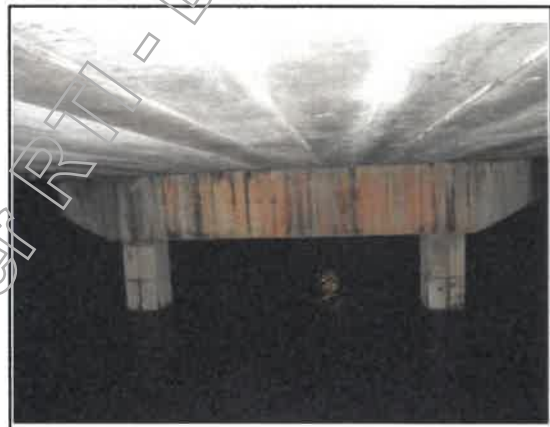
Id **Date**
Film / Exposure Number **Sketch No**
Description
 Pier 2 View.
Mod **Category** **Number** **Comp Code** **Comp No**

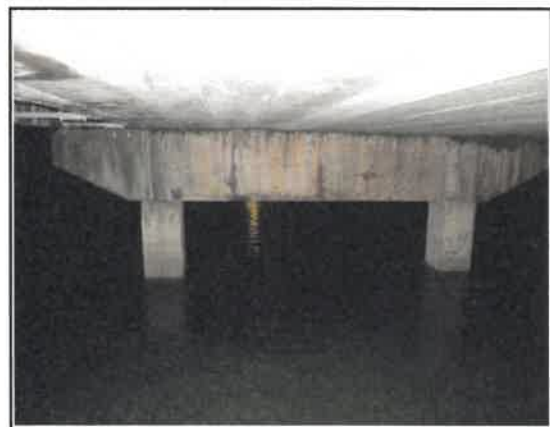
Id **Date**
Film / Exposure Number **Sketch No**
Description
 Pier 1 View.
Mod **Category** **Number** **Comp Code** **Comp No**

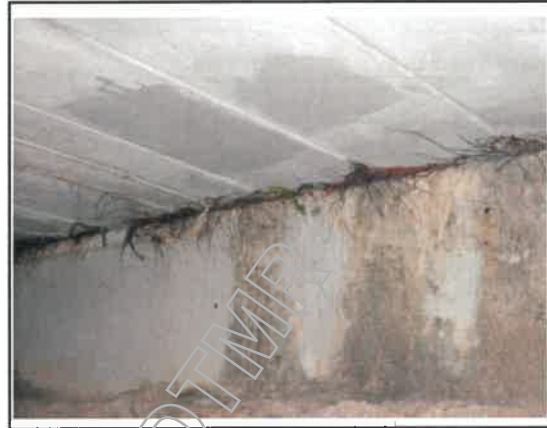
Mod	Category	Number	Comp Code	Comp No
<input type="text" value="O"/>	<input type="text" value="A"/>	<input type="text" value="2"/>	<input type="text" value="MP"/>	<input type="text"/>

Description
 Exception.

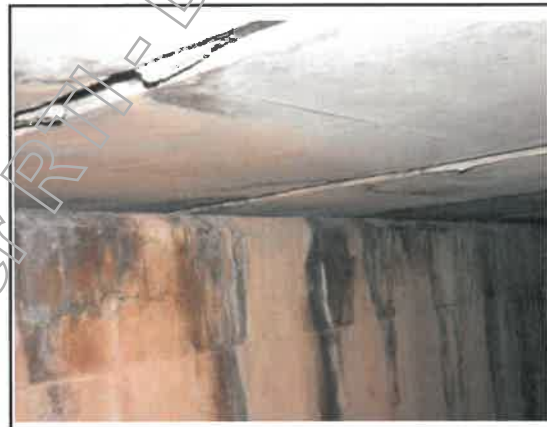
Mod	Category	Number	Comp Code	Comp No
<input type="text" value="O"/>	<input type="text" value="P"/>	<input type="text" value="2"/>	<input type="text" value="MP"/>	<input type="text"/>

Description
 Exception.

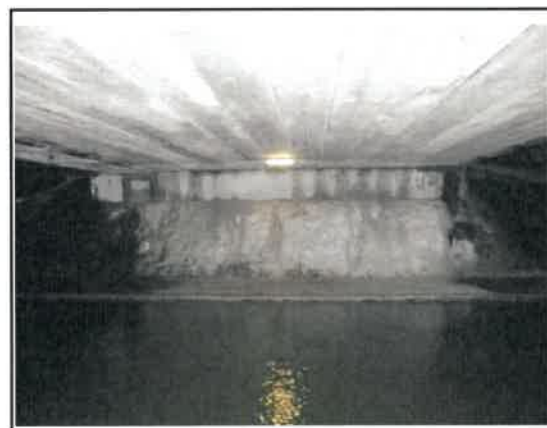
Mod	Category	Number	Comp Code	Comp No
<input type="text" value="O"/>	<input type="text" value="A"/>	<input type="text" value="2"/>	<input type="text" value="A"/>	<input type="text"/>

Description
 Abutment 2 View.

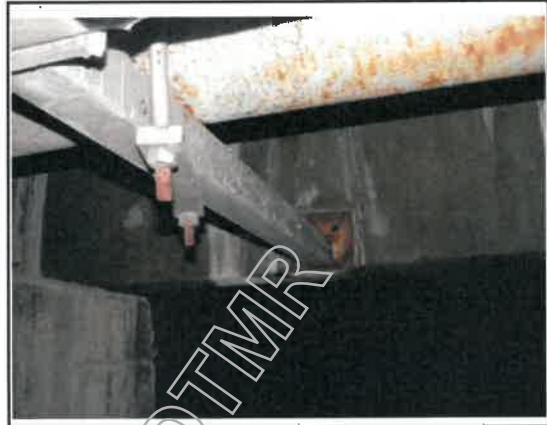
Mod	Category	Number	Comp Code	Comp No
<input type="radio"/>	S	2	D	<input type="text"/>

Description
Corrosion.

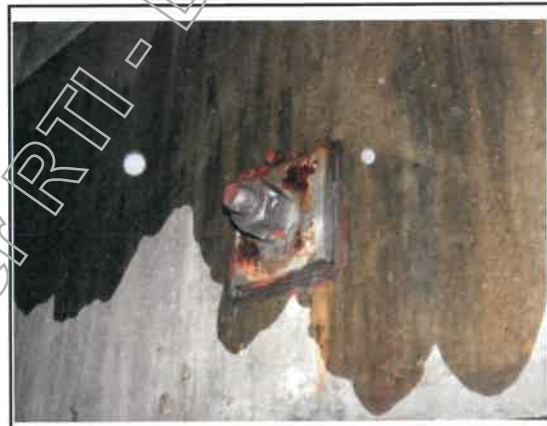
Mod	Category	Number	Comp Code	Comp No
<input type="radio"/>	S	2	D	<input type="text"/>

Description
Corrosion.

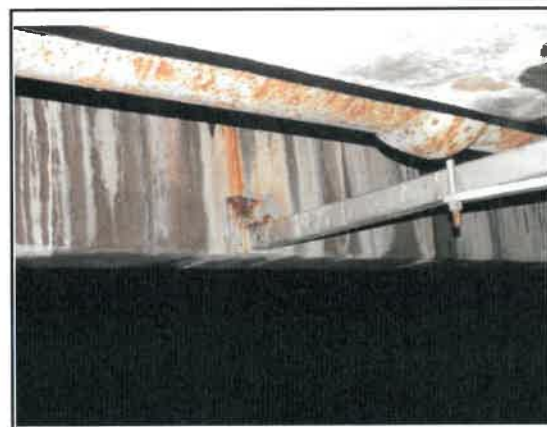
Mod	Category	Number	Comp Code	Comp No
<input type="radio"/>	S	3	D	<input type="text"/>

Description
Corrosion.

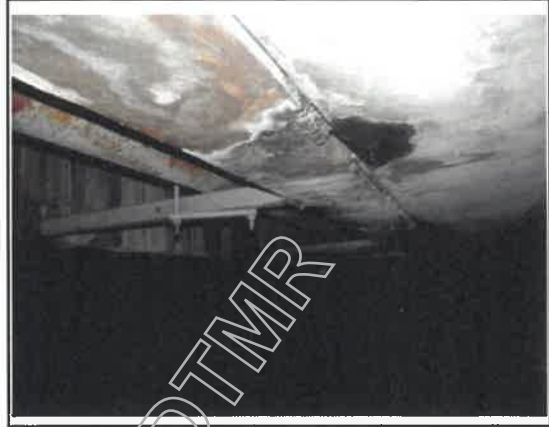
Corrosion.

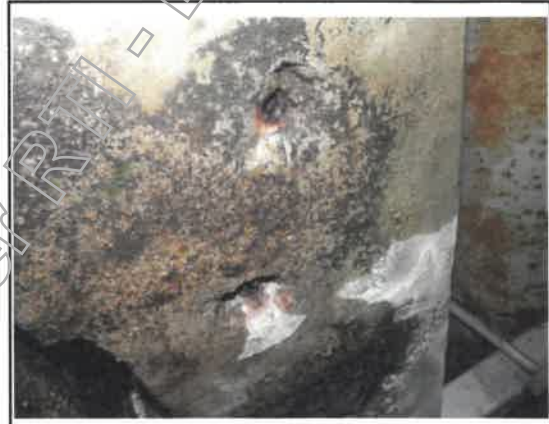
Spalling.
