**Technical Note 106**

# **Crevice Corrosion Defect**

**November 2015**

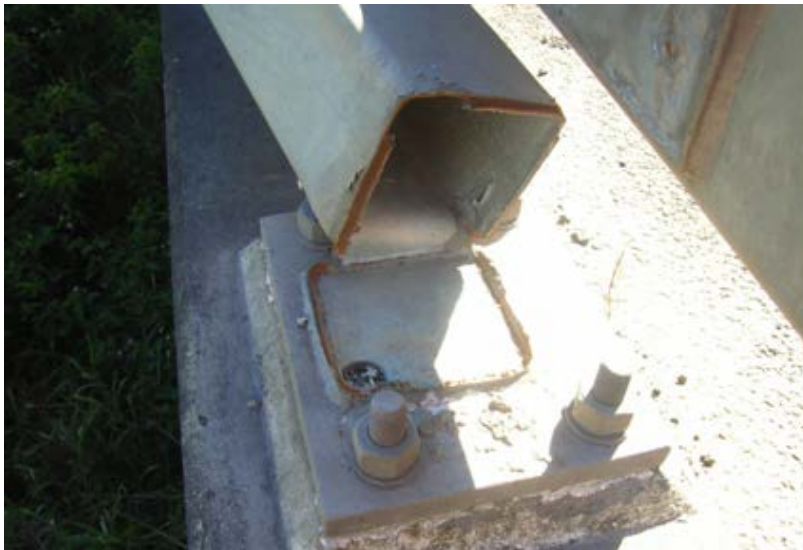
In the past all members were traditionally welded together with fillet welds to resist the design actions. TMR has found that when a hollow section is fillet welded to a base plate and the member is hot dip galvanised, corrosion is formed in the area under the hollow section material, refer to Figure 1.

The reason the corrosion commences is due to the pickling solution not being removed in the galvanising process. This pickling solution is hygroscopic (Attracts moisture) lead to the corrosion. The extent of the corrosion can vary. Figure 4 shows the corrosion which was found when two back to back angles were galvanised and the pickling solution was trapped between the members.

***Figure 1 – View of the corrosion that occurs between the parent materials***

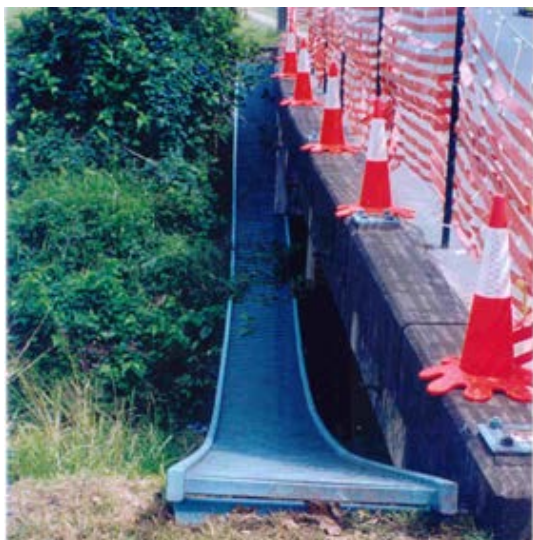
As there is no zinc in this particular area, corrosion begins to occur and overtime, the corrosion can lead to the failure of members, as shown in Figure 2 and Figure 3.

***Figure 2 – View of hand rail which failed due to corrosion around the base plate***

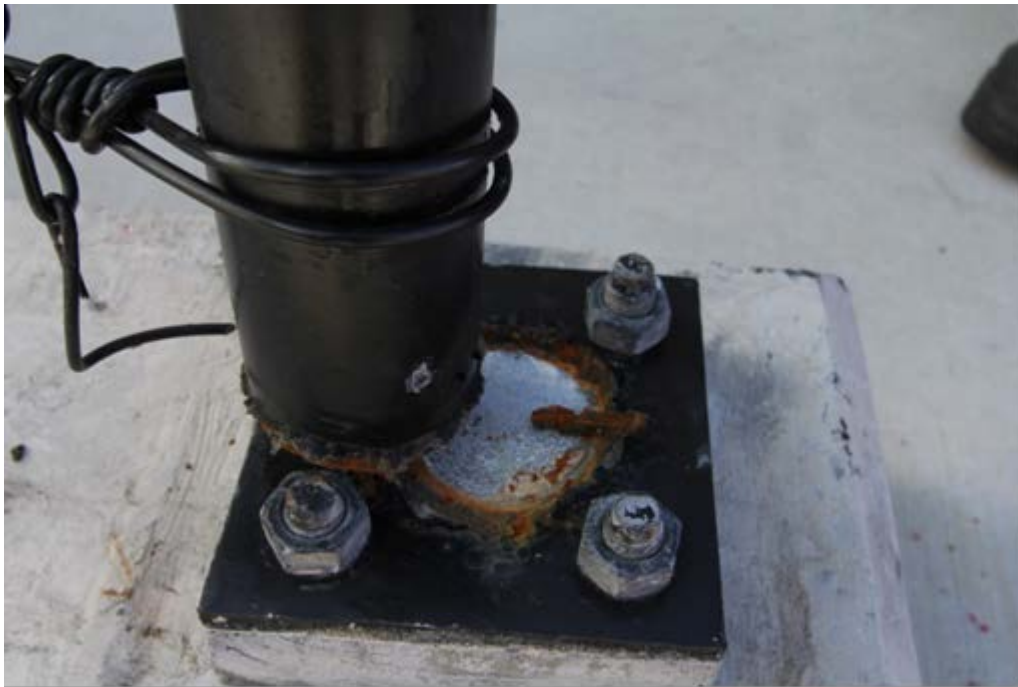
**Figure 3 – View of the failure of a fence post after one year**

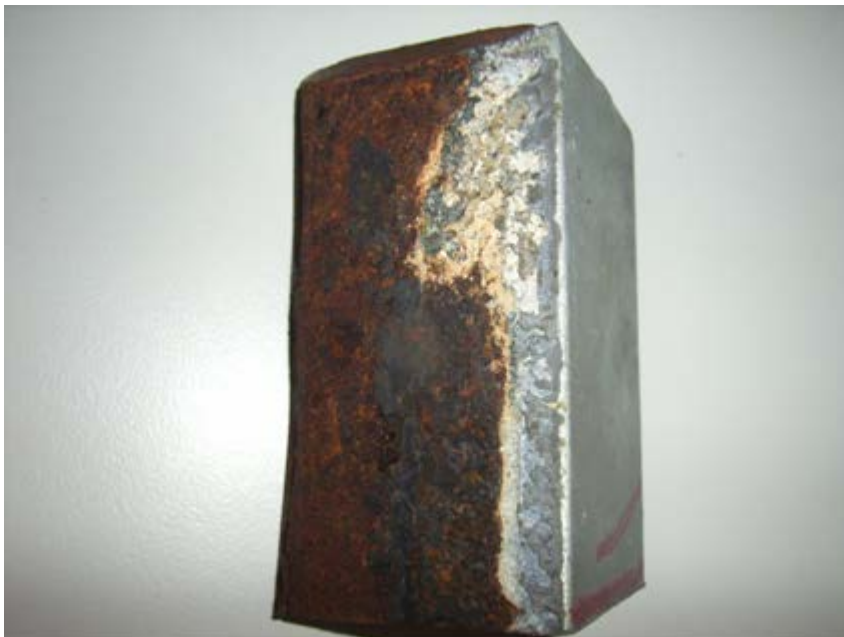
**Figure 4 – View of the corrosion when two back to back angles were placed against one another**

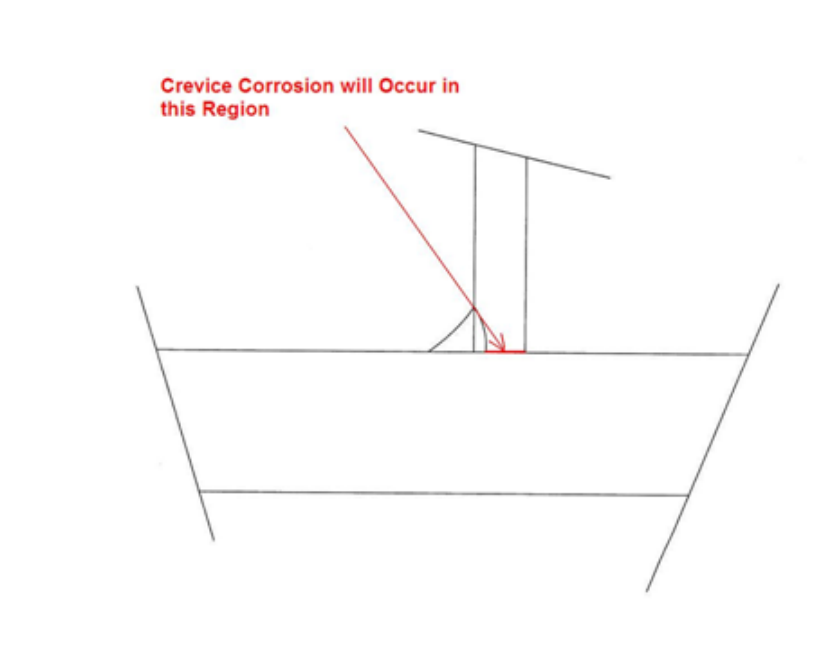
In a design specifies a fillet weld for hollow section material the crevice corrosion defect will occur in the area under the hollow section being welded, refer to Figure 5.

**Figure 5 – View of the crevice corrosion when a fillet weld is used**

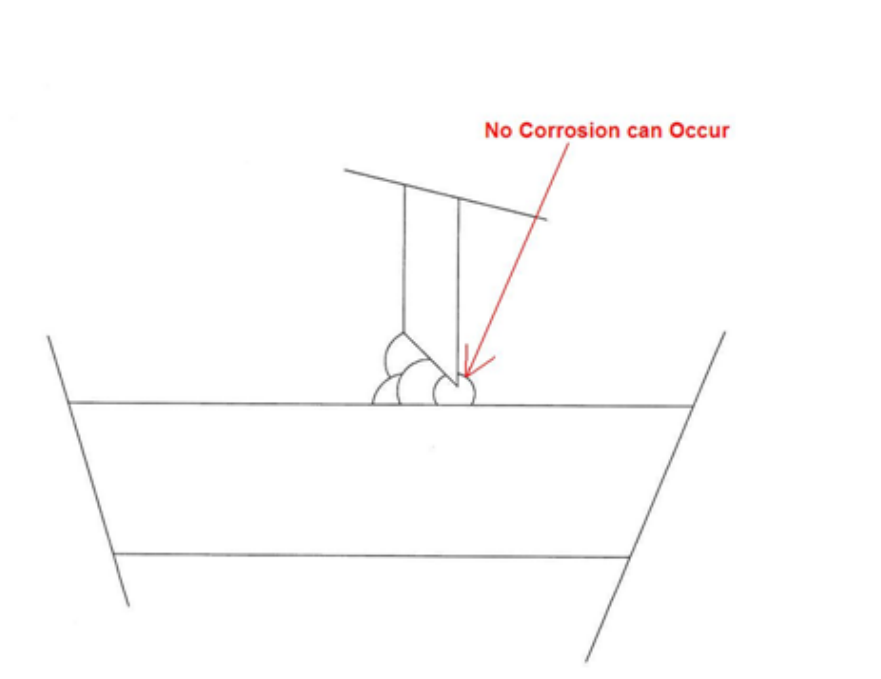
**Figure 6 – Design criteria specifies a butt weld**

In order to solve the crevice corrosion problem, TMR has found that when a butt weld is used, the crevice problem disappears, if the member is galvanised correctly in accordance with the requirements of AS/NZS 4680. Figure 6 shows the butt weld of the member resolves the crevice corrosion problem.

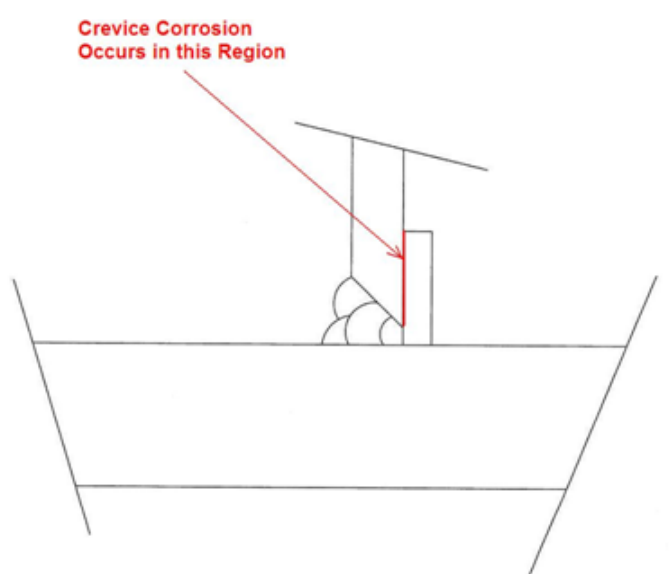
In the current version of AS/NZS 1554.1 the pre-qualified joints in the standard require butt welds to be placed with a backing bar. If the backing bar is permanently left inside the member, the crevice corrosion defect will still occur, as the top of the backing bar is not sealed off, refer to Figure 7.

**Figure 7 – View of the crevice corrosion defect when a backing bar is used**

Fabricators can place a butt weld without the need for a backing bar. The reason backing bars was introduced was due to the poor quality of welding being undertaken. TMR has solved this problem by

only allowing trade qualified staff to carry out welding on TMR project. As we are using higher skilled welders, there is no need for the backing bar.

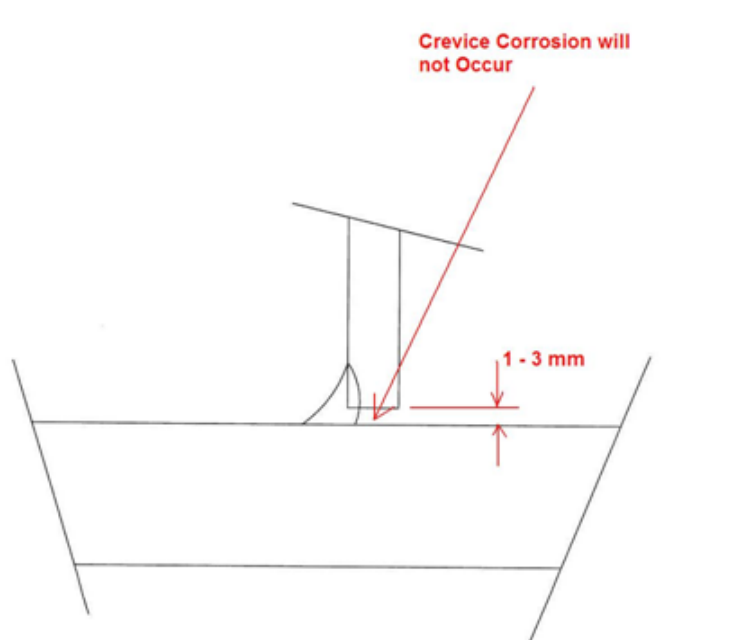
**Figure 8 – Alternative fillet weld detail to using butt welds**

TMR has been trialling an alternative detail for the welding of hollow section material with fillet welds. Figure 8 shows that if a fillet weld was to be used for hollow section material, a root gap is required under the member so the pickling can be removed from under the hollow section member. This detail would be more suited to minor structures, such a fence posts and anti-glare screens on the top of parapets.
